ENVIRONMENTAL CONDITION OF RIVERS AND STREAMS IN THE OVENS CATCHMENT

Publication 908

June 2003

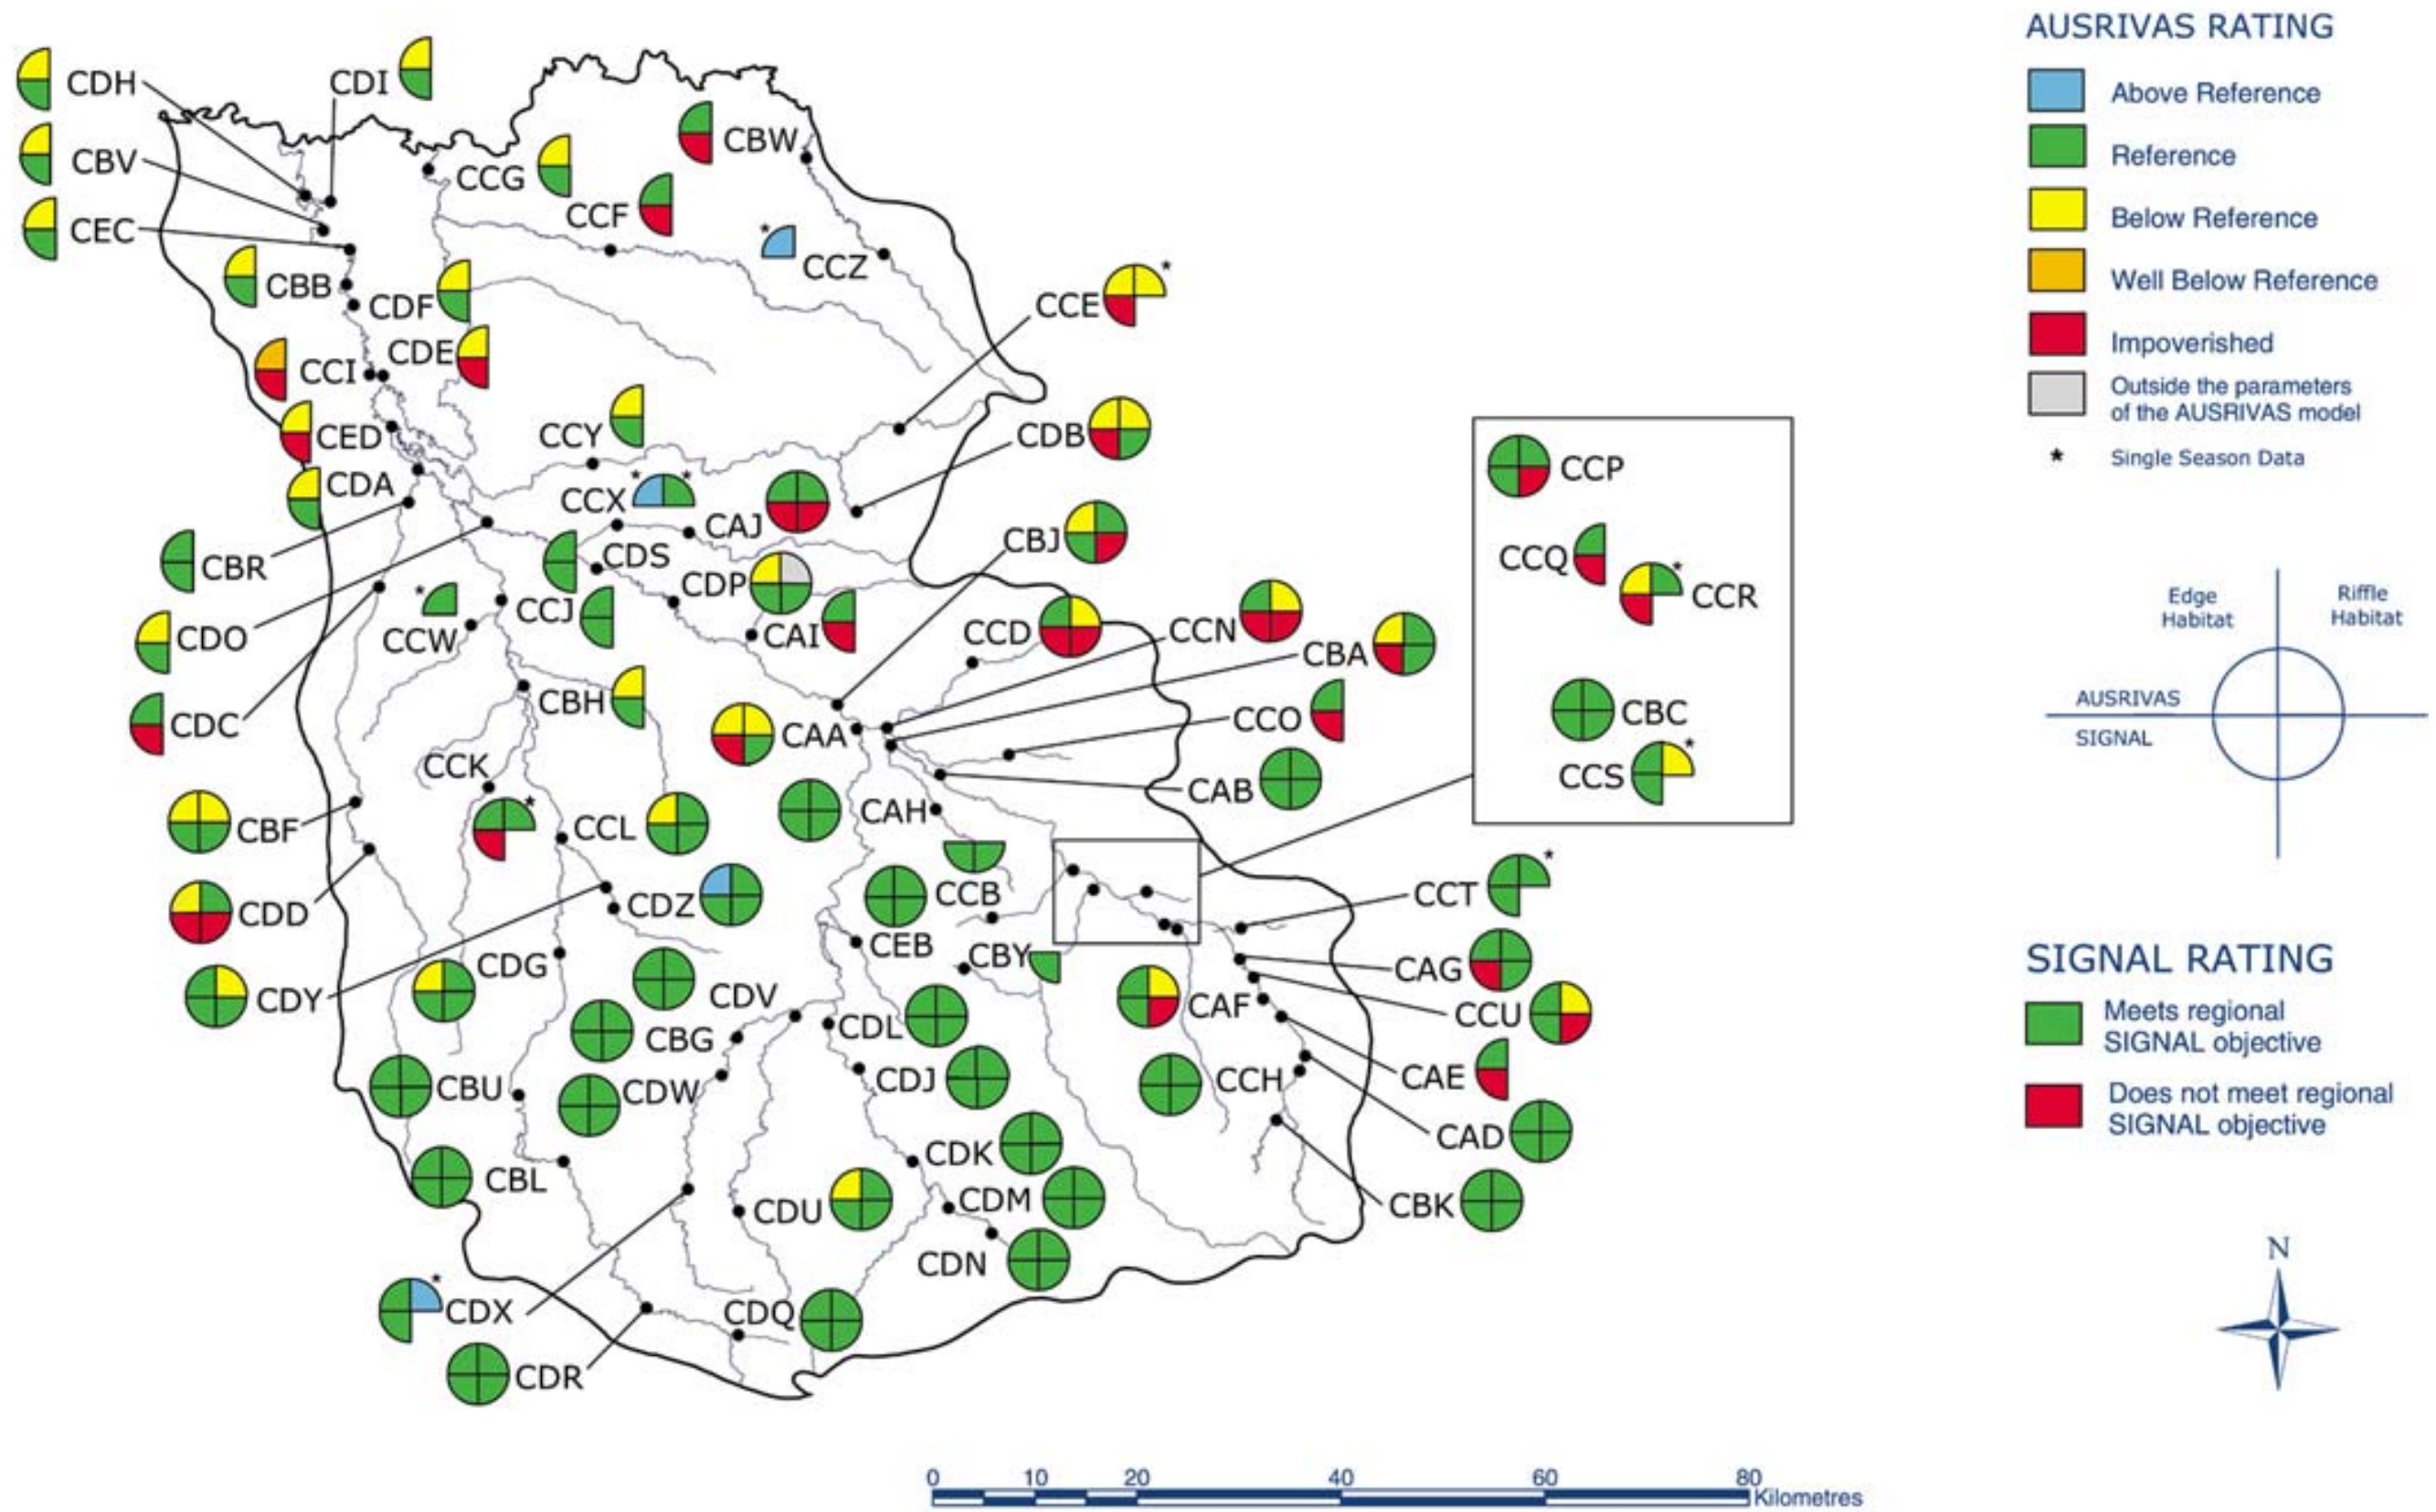
Figure 2: AUSRIVAS and SIGNAL ratings for sites in the Ovens catchment

Seventy-three sites in the Ovens catchment have been assessed. The results are presented in Figure 2 and Table 1. Sites were assigned to the biological regions⁵ and assessed against the biological objectives specific to the region in which they occur. None of the assessed sites was located in the Forests A biological region.
