Desktop Study and Preliminary Regional Conceptual Site Model

Fishermans Bend Urban Renewal Area

Client: Environment Protection Authority

AECOM Australia Pty Ltd

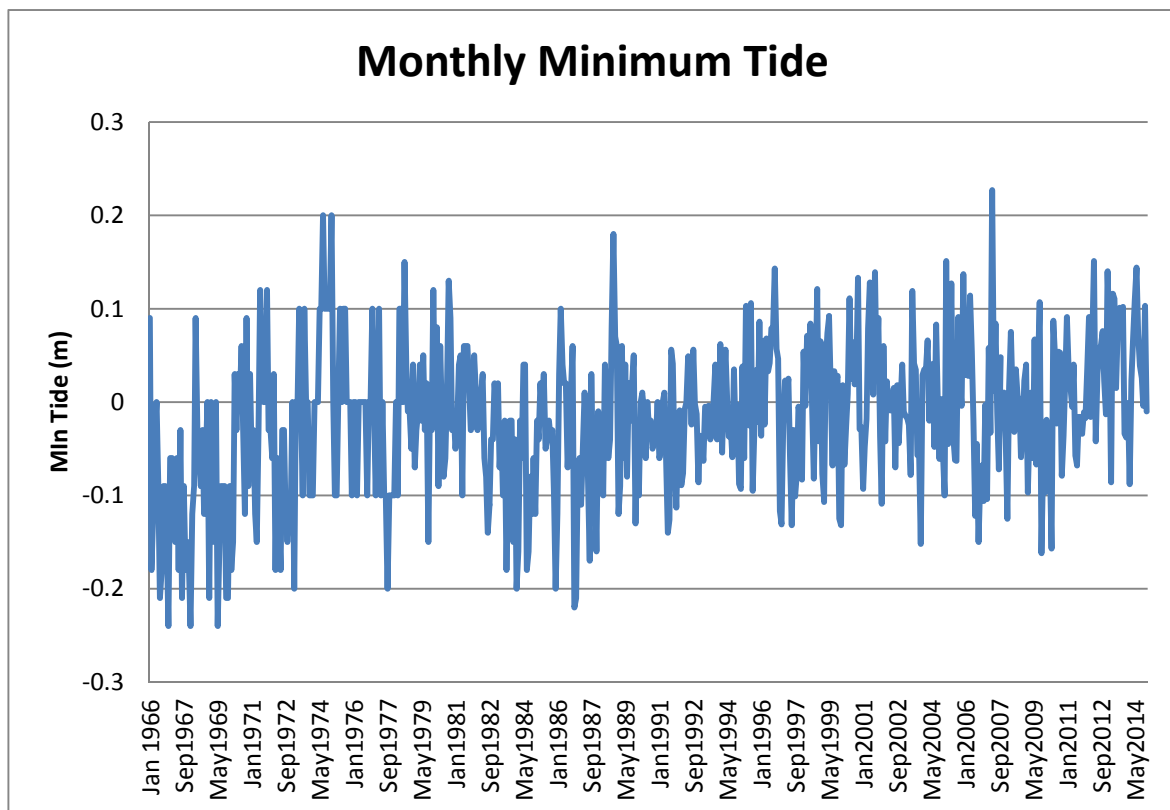
Graph 1 Monthly Minimum Tide between 1966 and 2014

Graphs 1 to 2 below depict the Monthly Minimum Tides and Monthly Maximum Tides between 1966 and 2014.

Based on the information presented above in relation to tidal variation (up to 0.759 MASL), the elevation of the site (0 - >4 mAHD) and the average depth of groundwater (approximately 3 meters below ground level (mBGL), there is expected to be significant tidal influence on the shallow groundwater. This tidal influence is expected to be greater particularly closer to the Yarra River to the north of the site and is likely to become damped towards the south. Further consideration of this on the regional groundwater quality including the impacts of regular flushing of water, salinity and migration pathways needs to be further assessed as part of future investigations.

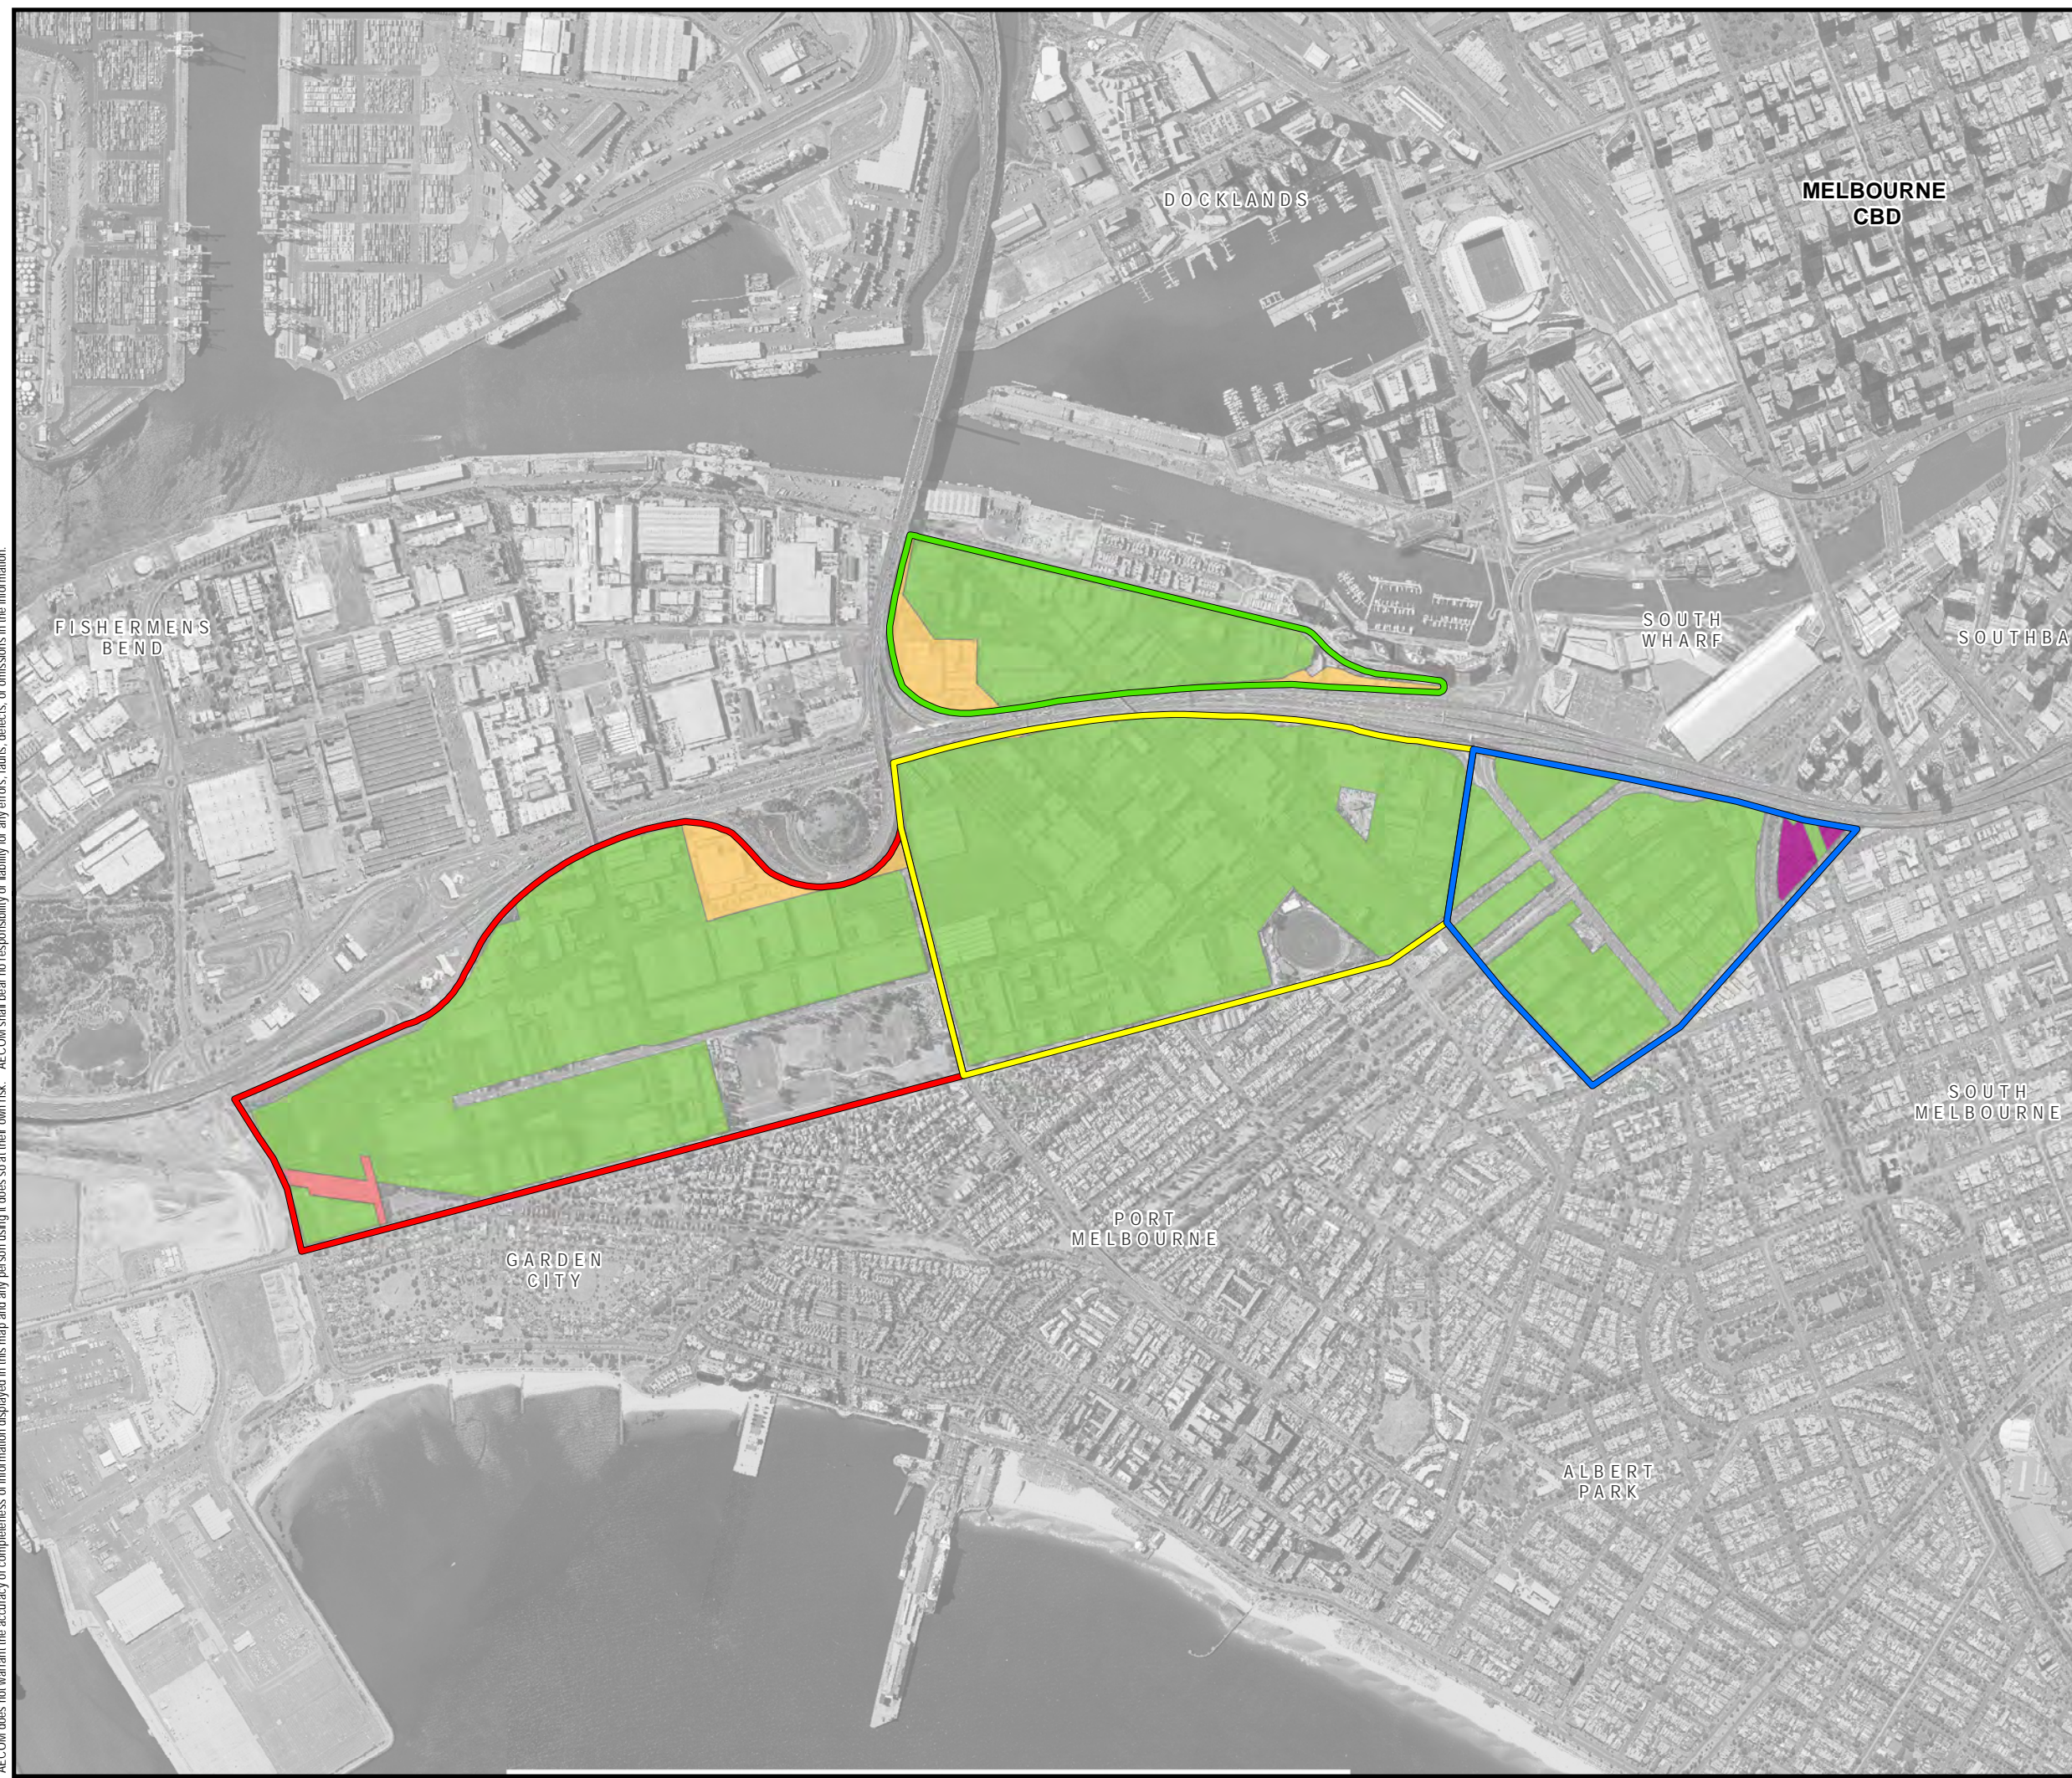
CURRENT PLANNING OVERLAYS - OTHER

- Lorimer Precinct
- Montague Precinct
- Sandridge Precinct
- Wirraway Precinct
- Airport Environs Overlay
- City Link Project Overlay
- Development Contributions Plan Overlay
- Environmental Audit Overlay
- Melbourne Airport Environs Overlay
- Public Acquisitions Overlay
- Restructure Overlay
- Road Closure Overlay

The site is generally used for heavy and light commercial and industrial processes which are described further in **Section 4.1**. The following table summarises the relevant site details. Please refer to **Figure F2** for the current zoning and **Figures 3a** and **3b** for overlay conditions across the site.

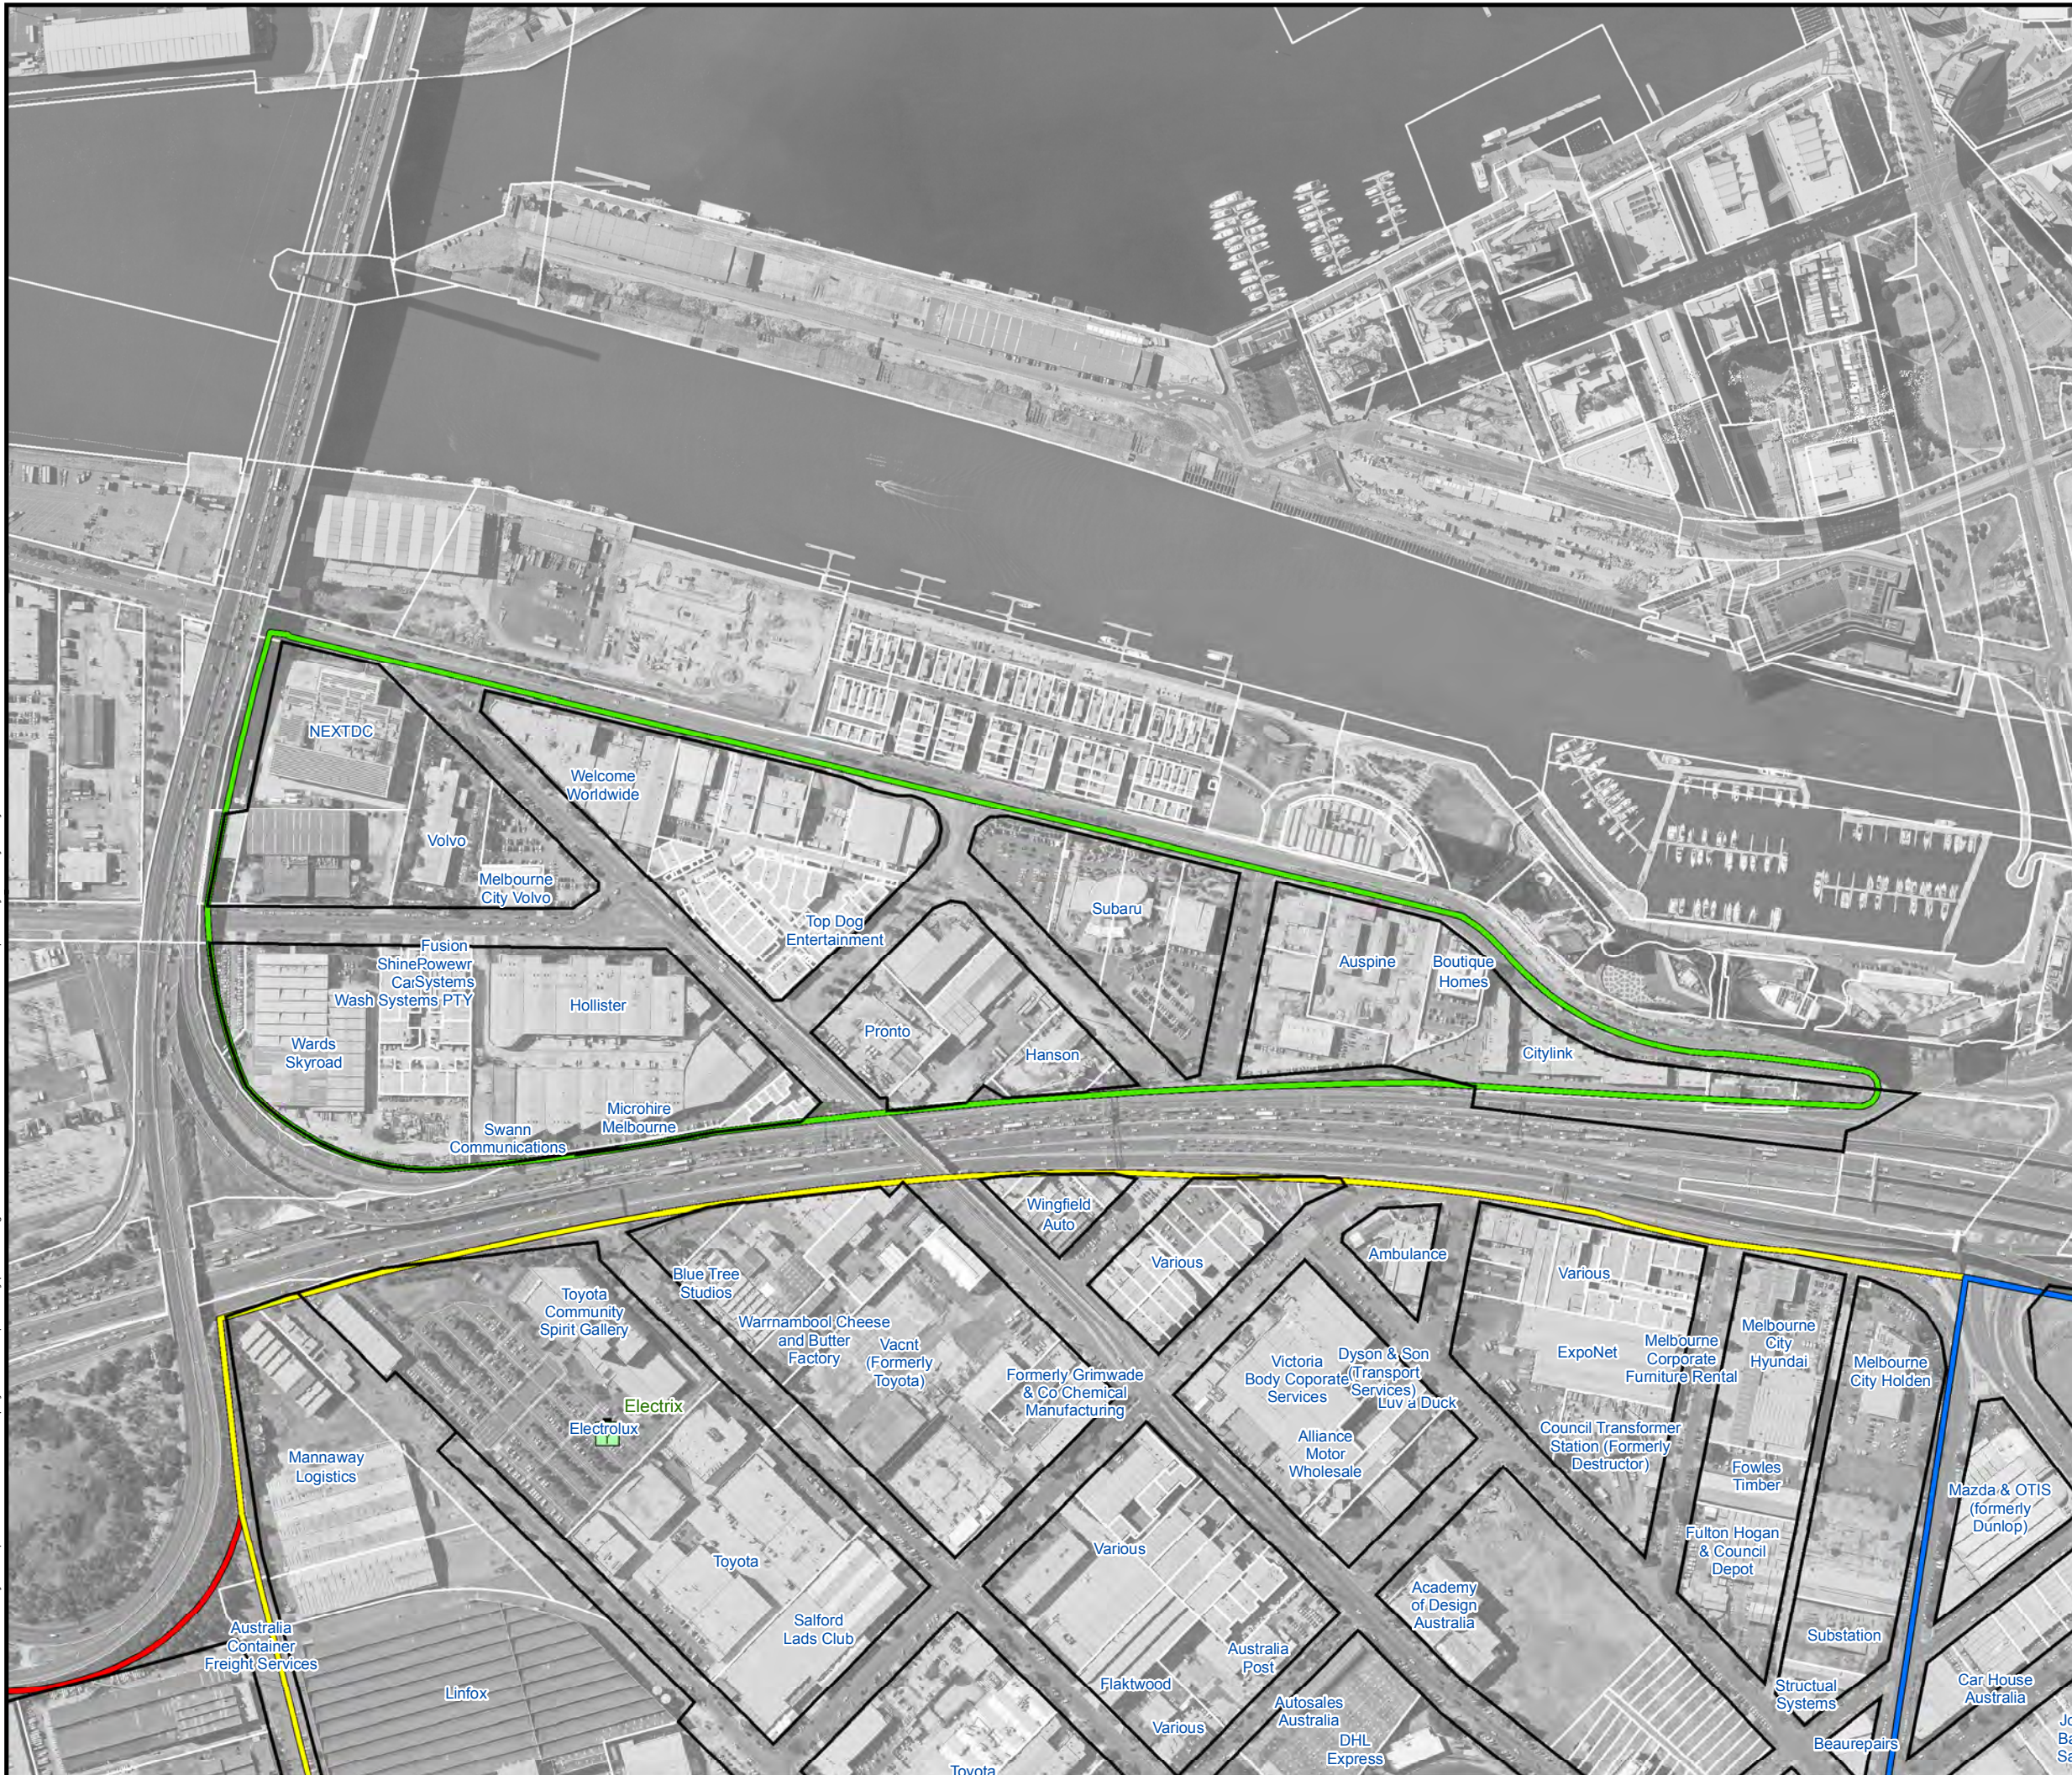
CURRENT LAND USES - LORIMER

- LEGEND**
- Petrol Stations
 - Lorimer Precinct
 - Montague Precinct
 - Sandridge Precinct
 - Wirraway Precinct

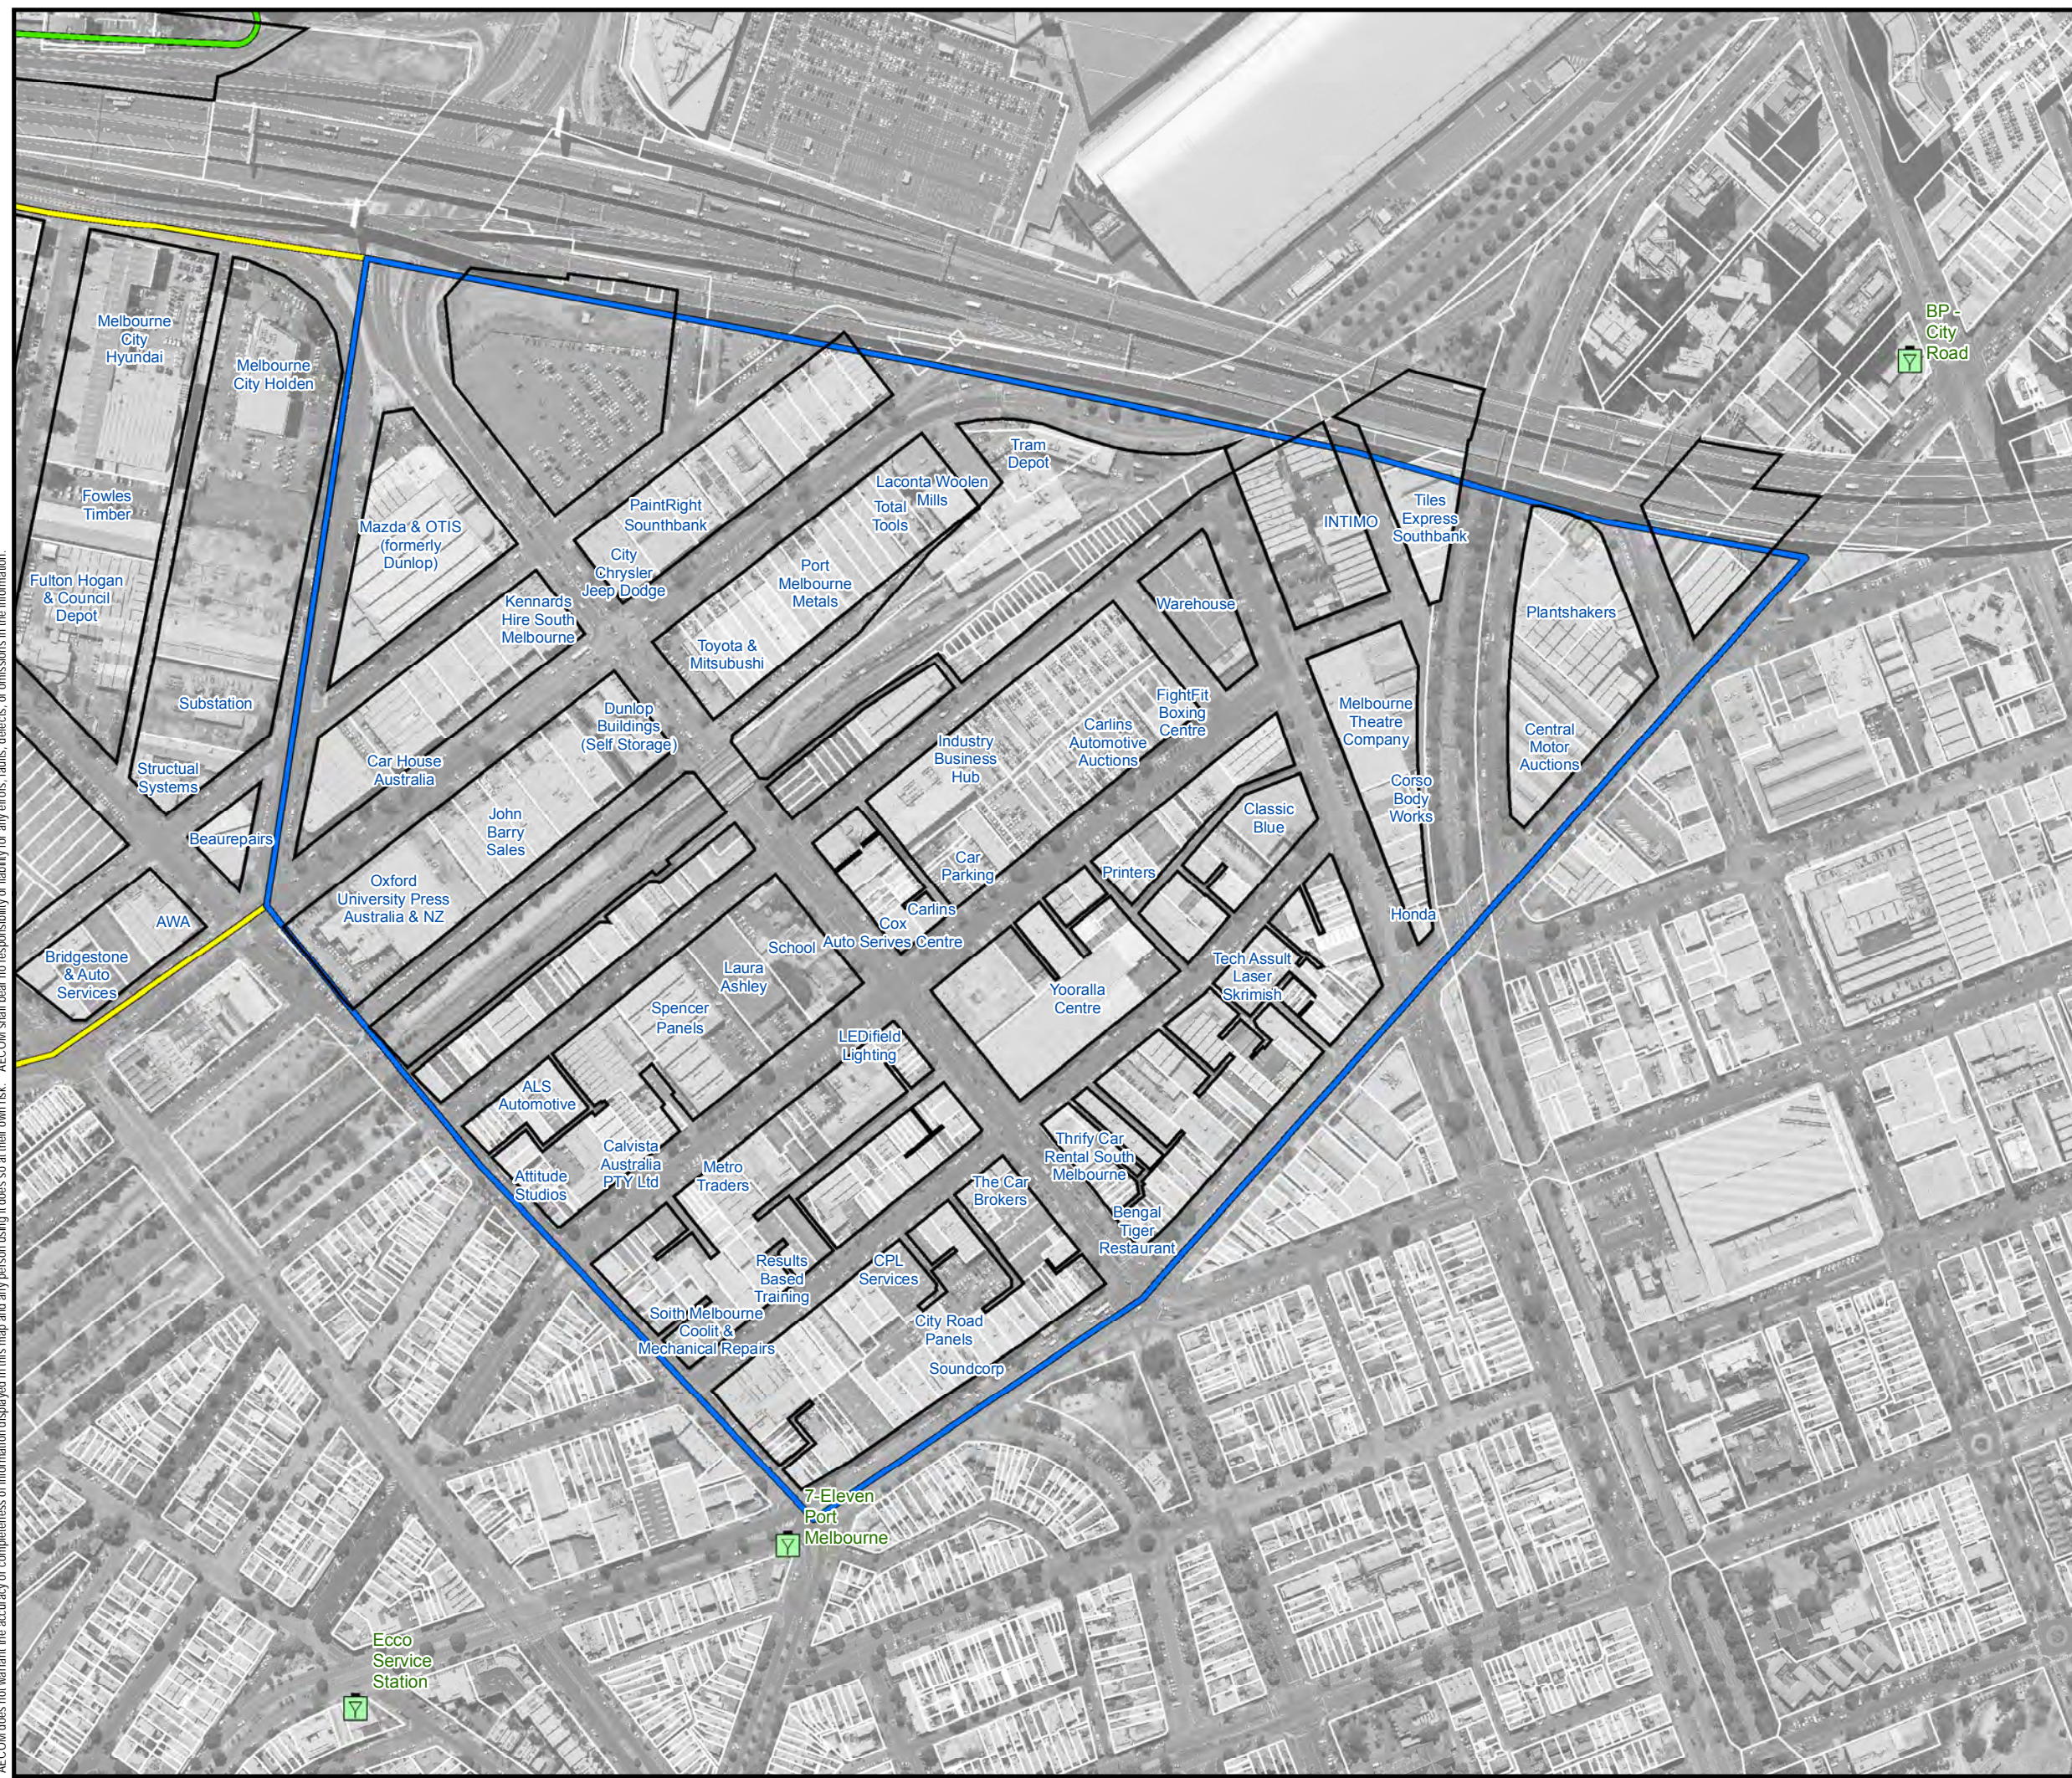
CURRENT LAND USES - MONTAGUE

- LEGEND**
- Petrol Stations
 - Lorimer Precinct
 - Montague Precinct
 - Sandridge Precinct
 - Wirraway Precinct

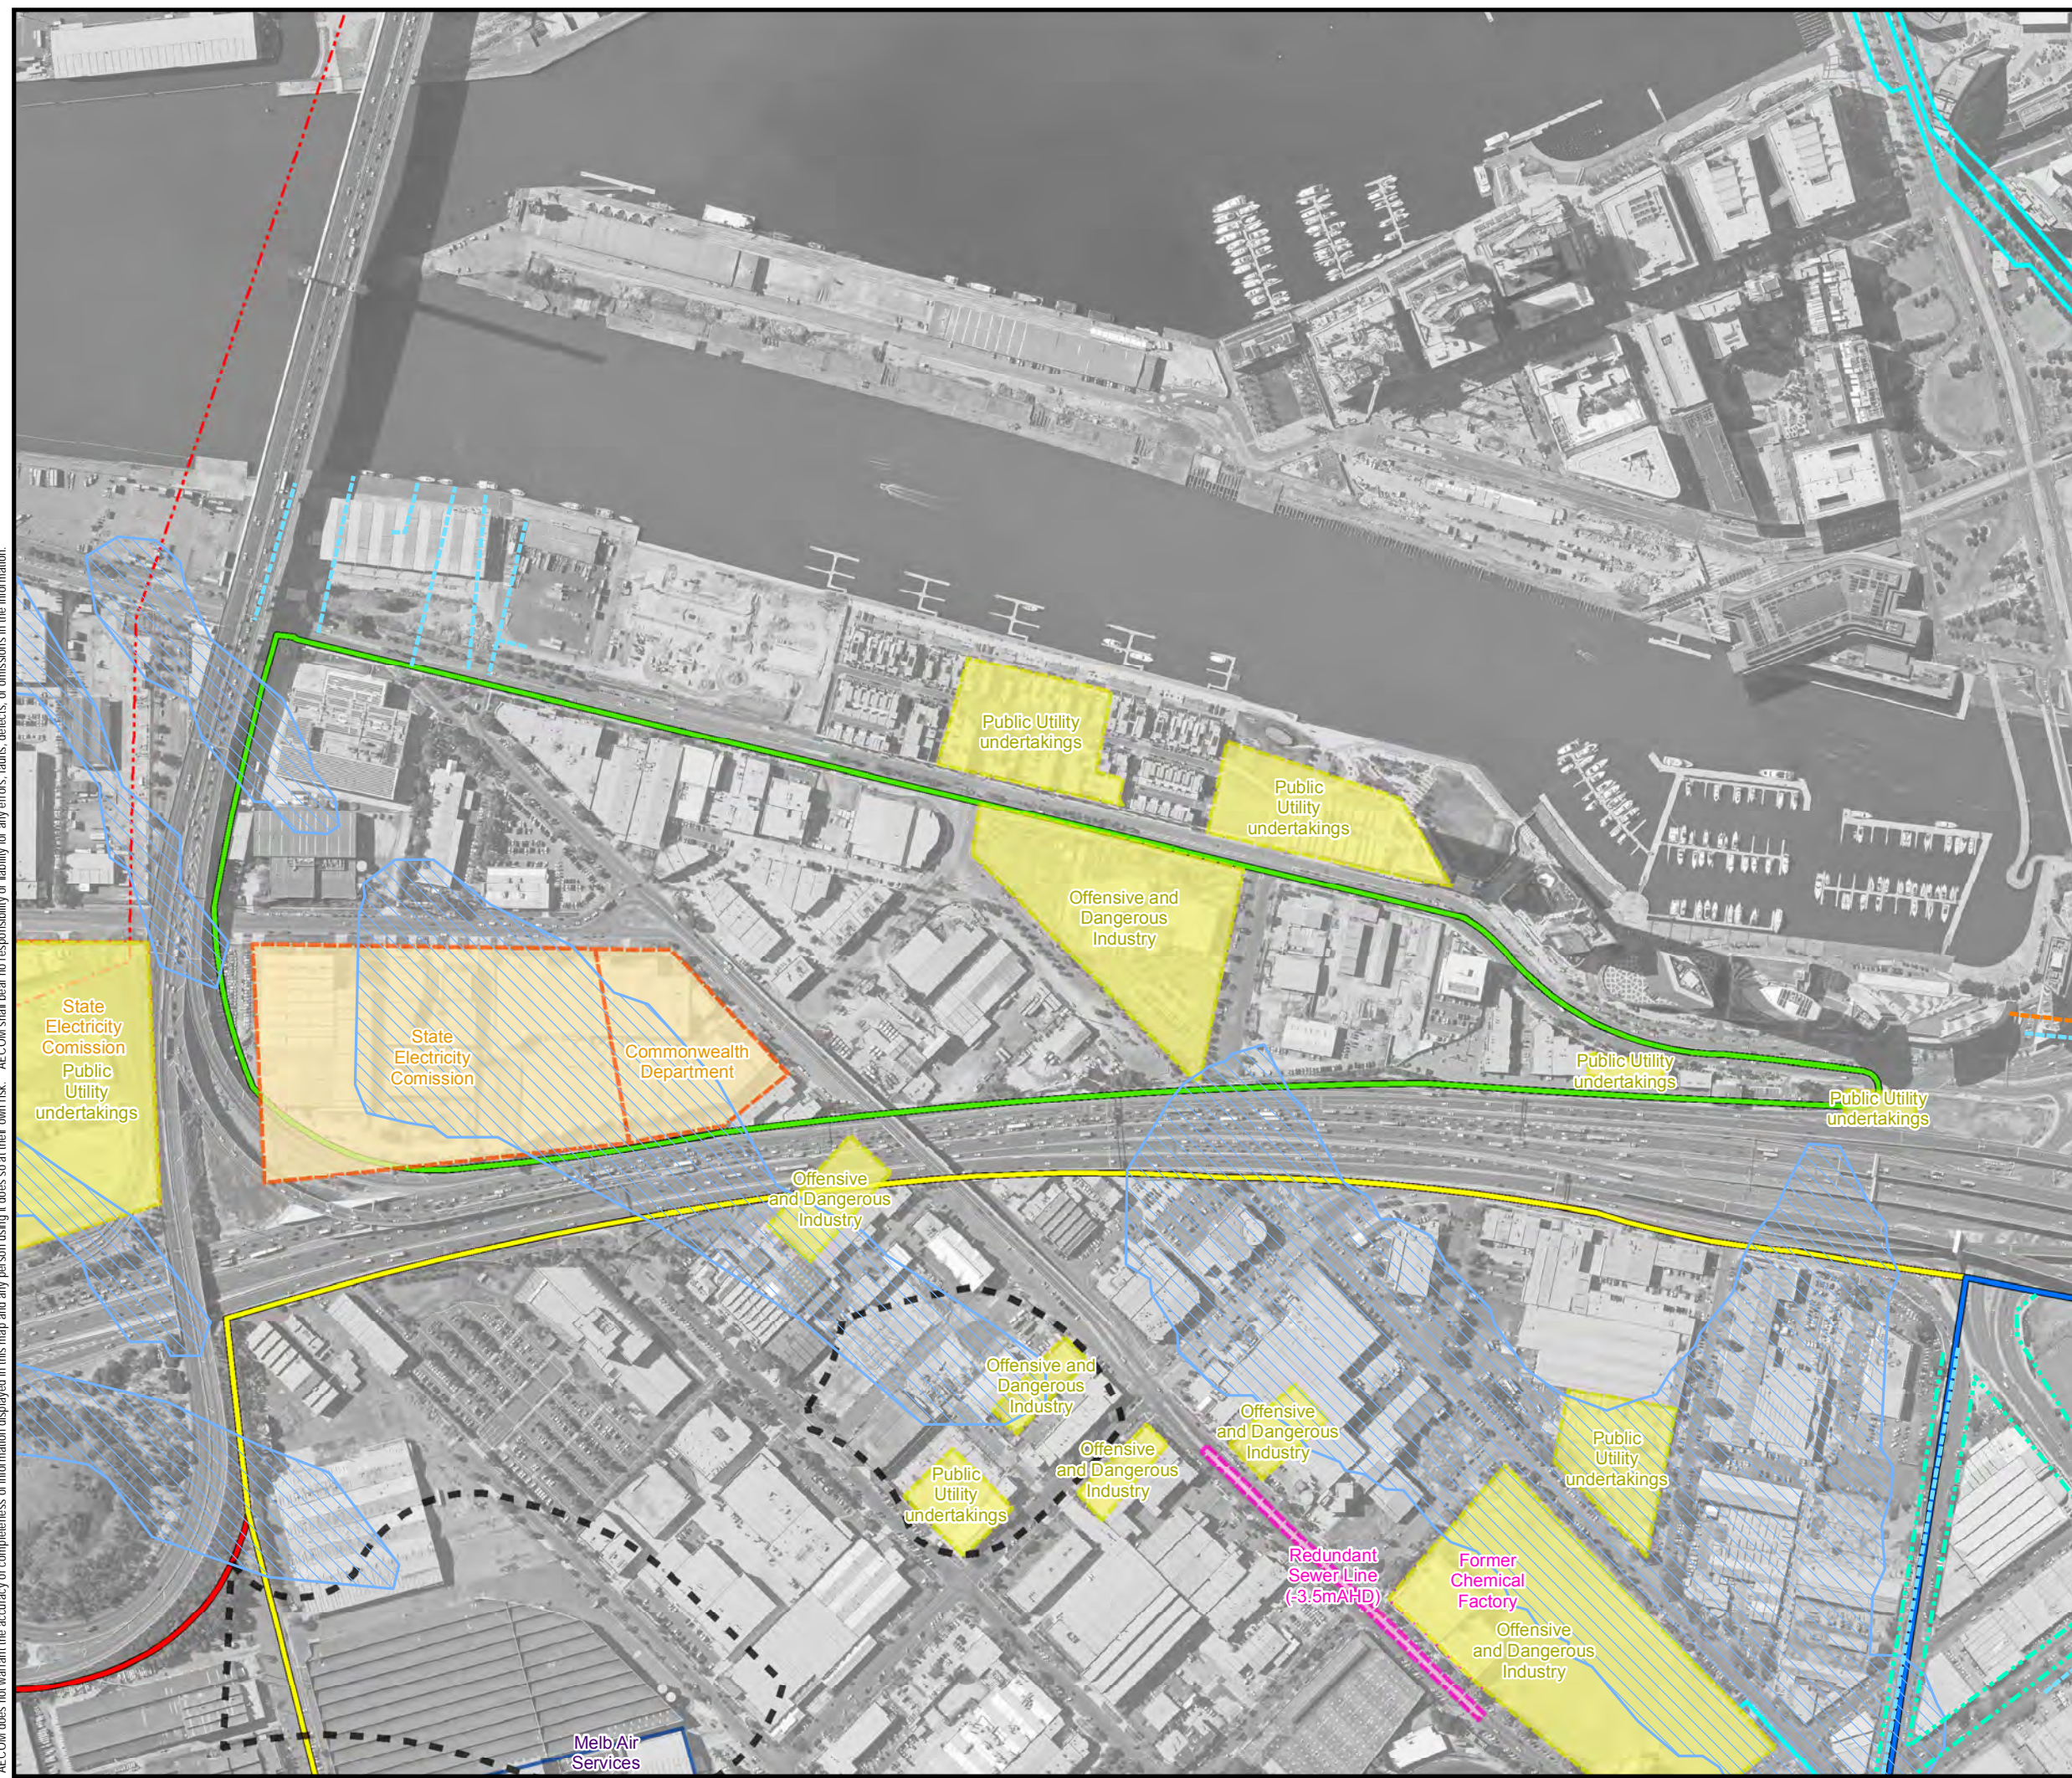
KEY HISTORICAL FEATURES - LORIMER

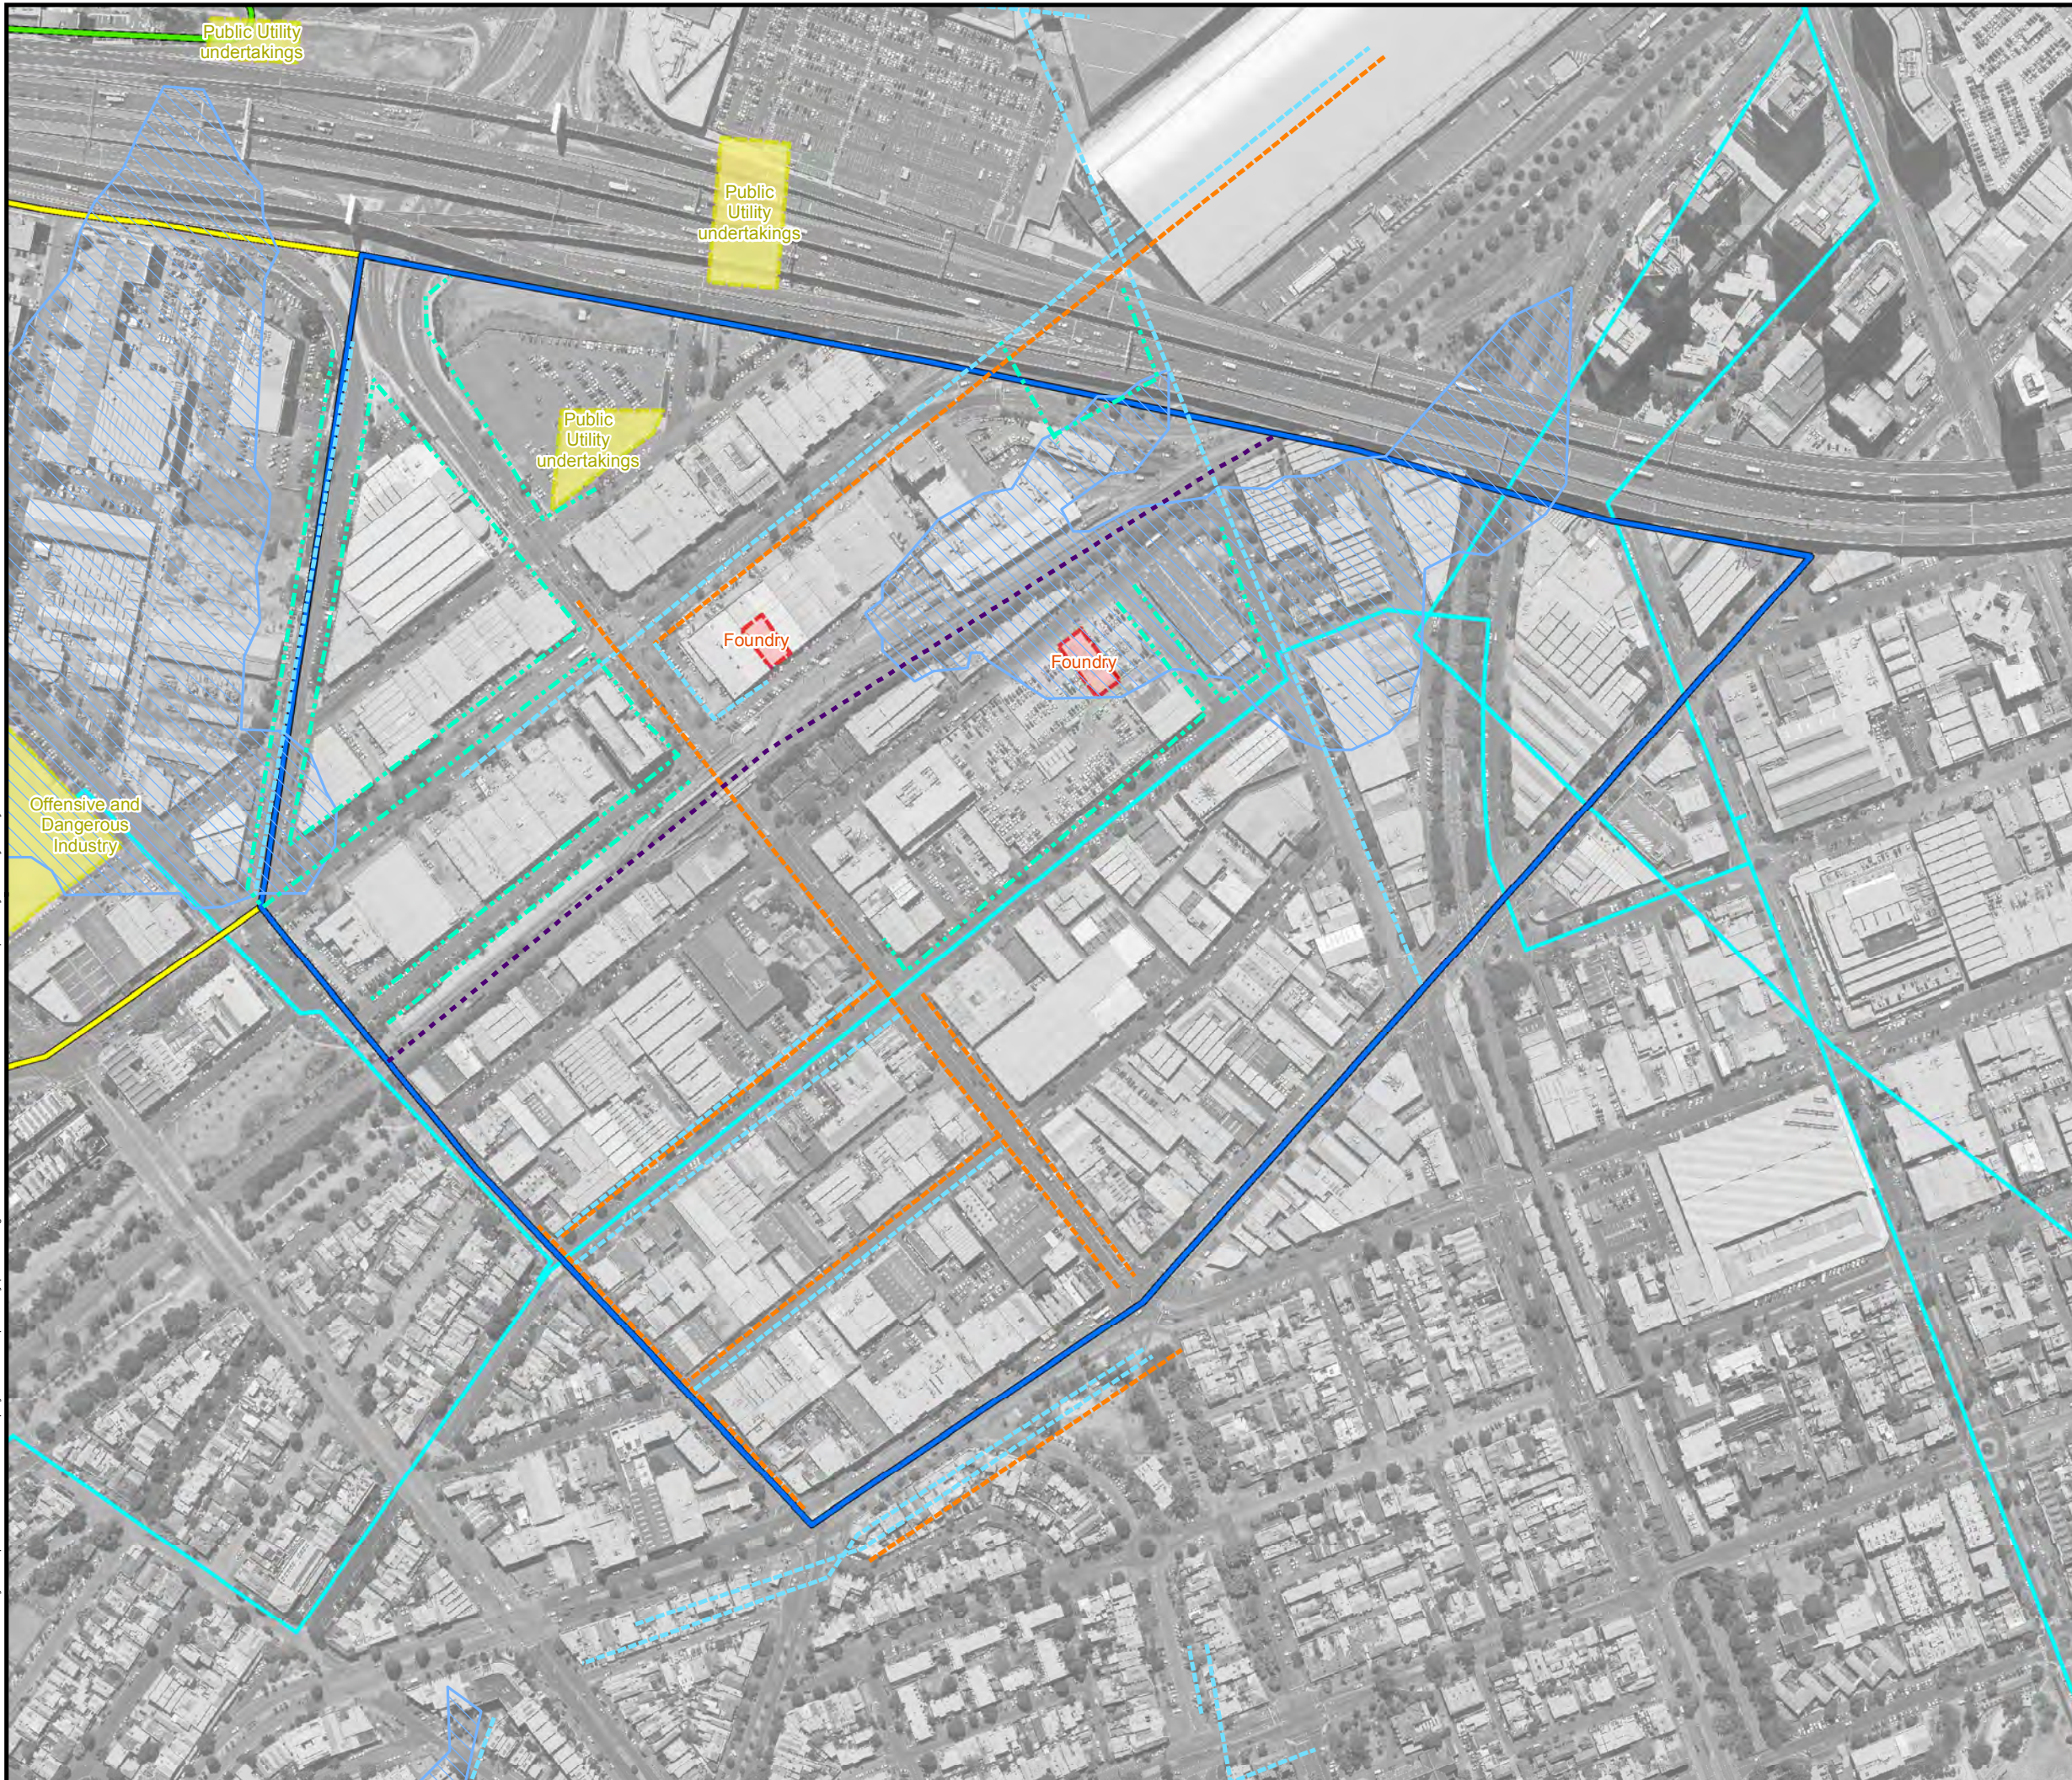
- LEGEND**
- Historic Utilities**
- 24" Shell Fuel Pipeline
 - Water
 - Gas
 - Rail
 - Swerage/ Stormwater
 - Hobson's Bay Main
 - Transmission Line
 - 1895
 - 1933
 - 1954
 - 1968
 - Historical Aerodrome
 - Historical Quarry / Landfill
 - Wetlands (1788)
 - Lorimer Precinct
 - Montague Precinct
 - Sandridge Precinct
 - Wirraway Precinct

The location of both of the mains at the site (**Figure F6**) and possible construction methodology will help to inform any assessment on groundwater levels at the site and may explain localised discrepancies (if identified). We recommend that this potential influence be considered during any future groundwater gauging and sampling events.
