ENVIRONMENT REPORT

**ENVIRONMENTAL CONDITION  
OF RIVERS AND STREAMS IN  
THE OVENS CATCHMENT**

Freshwater Sciences

Publication 909

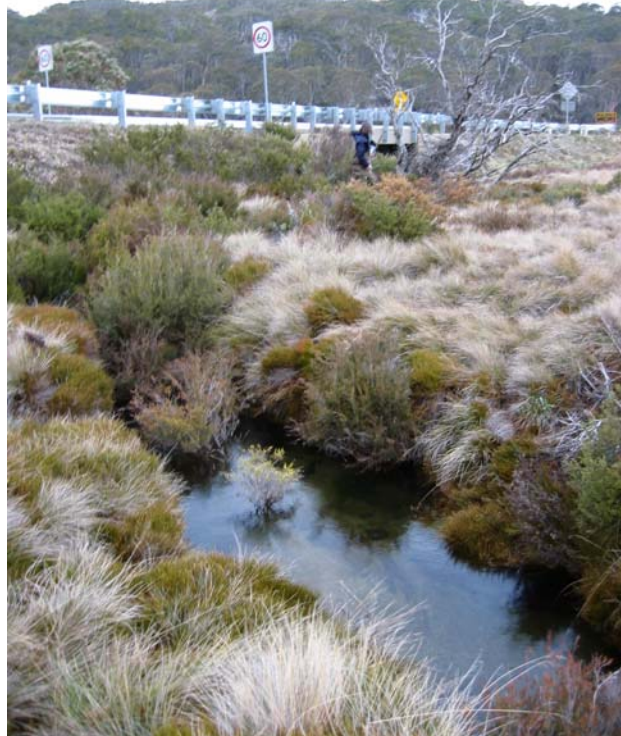
**Figure 3: Crystal Brook at Mount Buffalo (CCB)**

As the name suggests, the Highlands Region is restricted to the high country of Victoria, with streams often on steep slopes, generally above 1000m and subject to high rainfall. The vegetation tends to be native forest, woodland and grassland. Riparian shading varies from moderate to low cover, depending on the flow of streams through forested or grassland areas, respectively. The streams tend to be small (compared to other biological regions). They also have the lowest water temperatures, and very low alkalinity, turbidity and salinity. The stream habitat is generally characterised by the presence of riffles and limited edge habitat, with coarse substrate, and low macrophyte cover and diversity. An example of a site in this region is Crystal Brook at Mount Buffalo (CCB) (Figure 3).

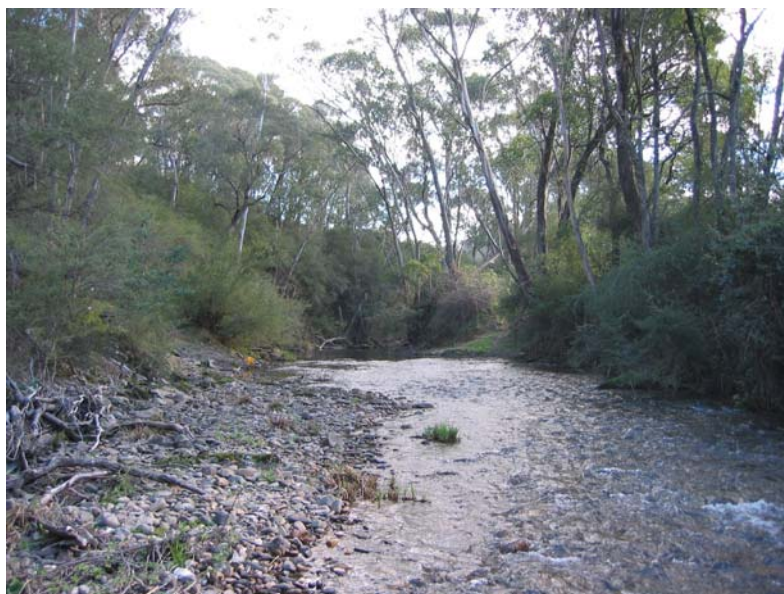
**Figure 4: Dandongadale River at Pine Plantation Track (CDV)**

The Forests B Region incorporates the Otway Ranges, Alpine National Park and the foothills of the Great Dividing Range to form a discontinuous region supporting tall open forests. The region generally covers areas lower in altitude than the Highlands Region. Stream slopes are less steep and rainfall is moderate to high. Forestry and agriculture dominates this region. Streams are generally large, with more than double the catchment area of streams in the Highlands Region. Alkalinity of the cool waters typical of this region is slightly elevated relative to the Highlands Region, but still remains low along with turbidity and salinity. Stream habitat is characterised by the presence of riffles and edges, with very coarse substrate and high macrophyte diversity and cover. Figure 4 shows an example of this type of river in the Ovens catchment.

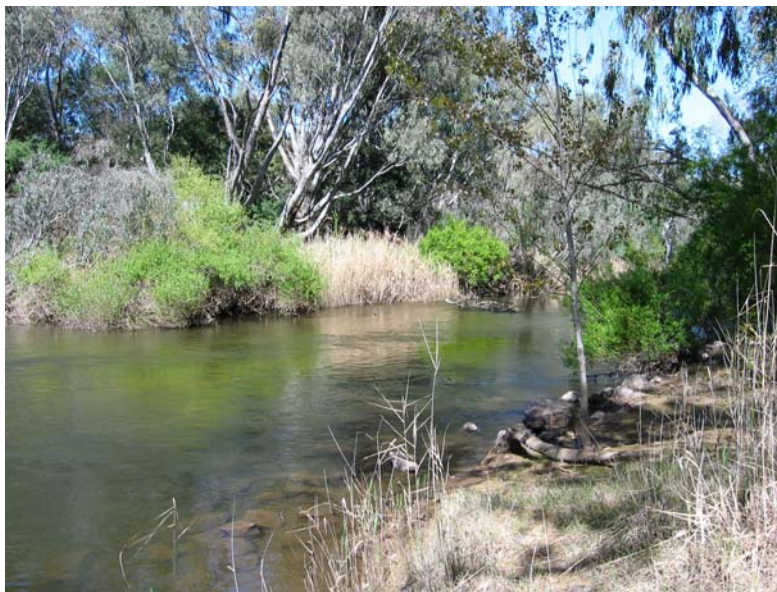
**Figure 5: Ovens River near Everton (CDP)**

The Cleared Hills and Coastal Plains region covers a wide area in Victoria ranging from coastal plains in the south, to inland plains and low foothills in the north and east. Streams usually flow through an undulating landscape of low altitude with little gradient and relatively low rainfall. In the Ovens catchment, this region is substantially cleared for intensive agriculture including dryland and irrigated pastures, resulting in poor riparian shading. Warm stream waters with high alkalinity, and low to moderate turbidity and salinity characterise the region. The edge habitat is more developed and extensive runs and riffles are less common. The substrate tends to be composed of moderate to fine particles, and a somewhat low diversity and moderate cover of macrophytes. The Ovens River near Everton (CDP) (Figure 5) is an example of a river in this region from the Ovens catchment.
